**2008-16 Ski-Doo XP 800R Single Pipe (carb)
134-117 Polished Ceramic**

Installation Instructions

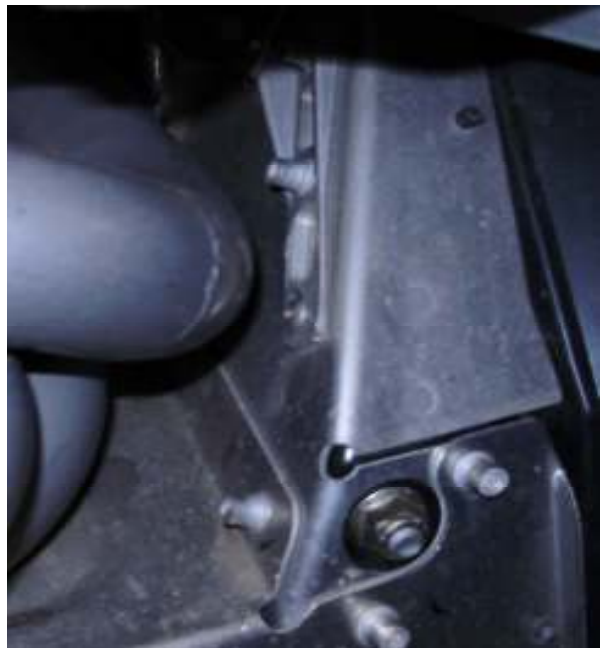
Re-install the button head screw as shown

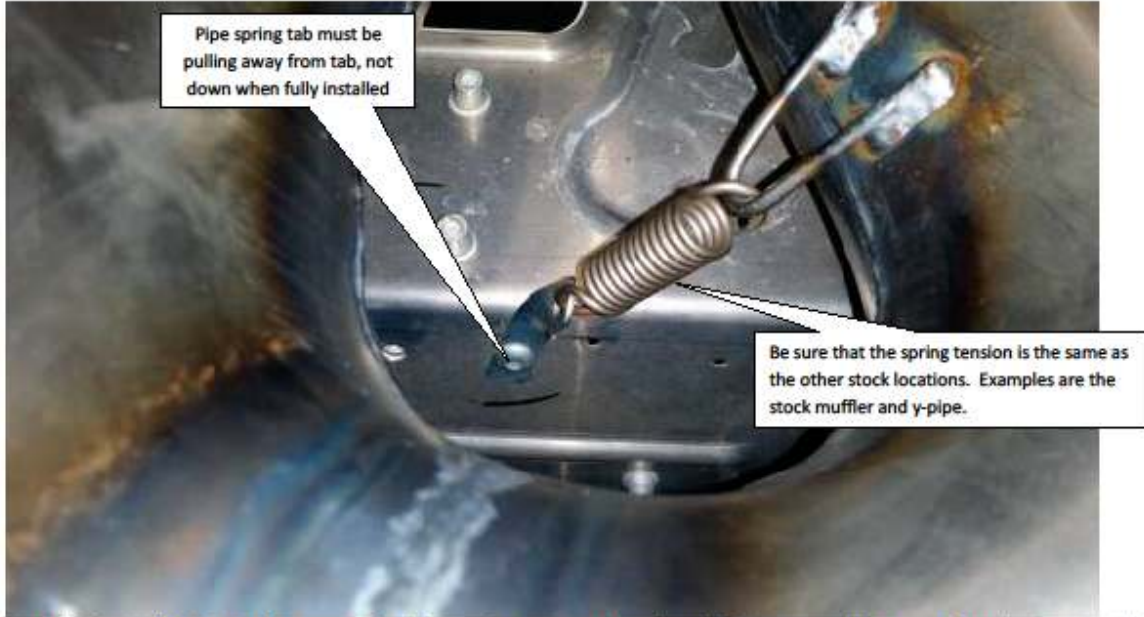
DUE TO THE LARGE DIFFERENCES FROM YEAR TO YEAR THE END USER MUST MOVE THE CENTER SPRING TAB TO THE PROPER LOCATION.

The 2010-2014 Ski-doo 800/600 E-TECs have moved and change the center spring tab multiple times over the 4 years of production. Straightline can no longer determine the location of the spring tab on the end users machine. As shown above the spring tab mount should have the proper tension as shown above. This may require drilling out the rivet and moving it more toward the chain case side of the snowmobile.
